Reconnaissance Survey of the
Historical Bridgeport Disposal Site
August 1992

Disposal Area Monitoring System DAMOS

Contribution 107
January 1996

Report No.
SAIC-C109

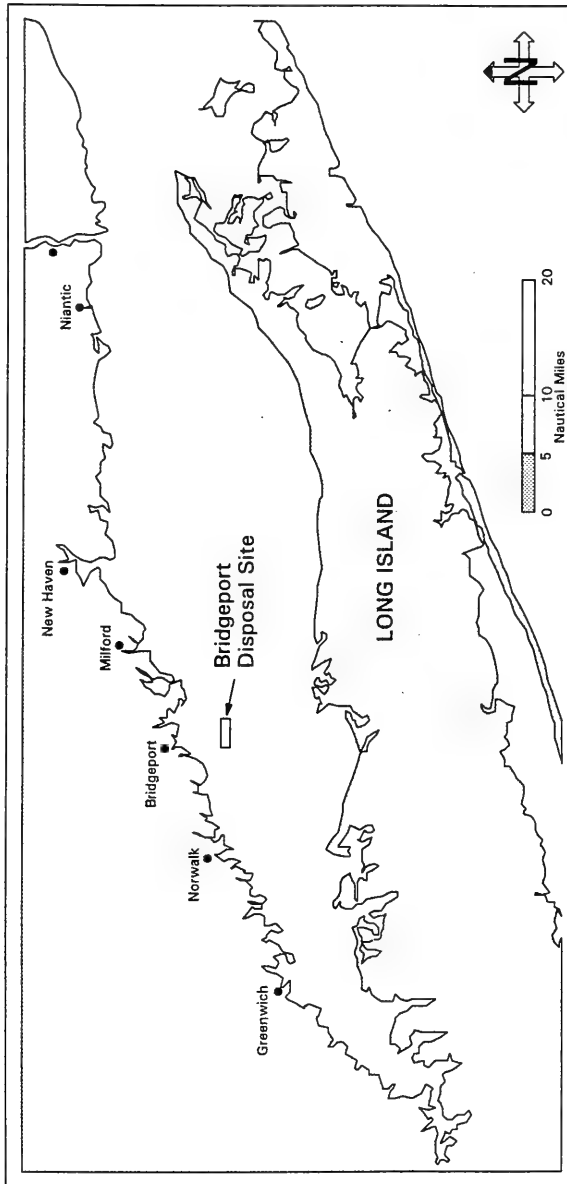
Figure 1-1. Long Island Sound and the historical Bridgeport Disposal Site

The Bridgeport Disposal Site is an inactive disposal site in Long Island Sound (Figure 1-1). It is located approximately 5 nmi south-southwest of the entrance to Bridgeport Harbor, Connecticut. The disposal site is 2 nmi long and 1 nmi wide (the long axis of which runs east-west) and is centered about 41°04.4' N latitude and 73°12.6' W longitude. The site was used frequently for dredged material disposal over a period of twenty-five years from 1953 to 1977. Until now, the site was never monitored under the DAMOS Program. The DAMOS Program began in 1977 around the time that site use was discontinued.

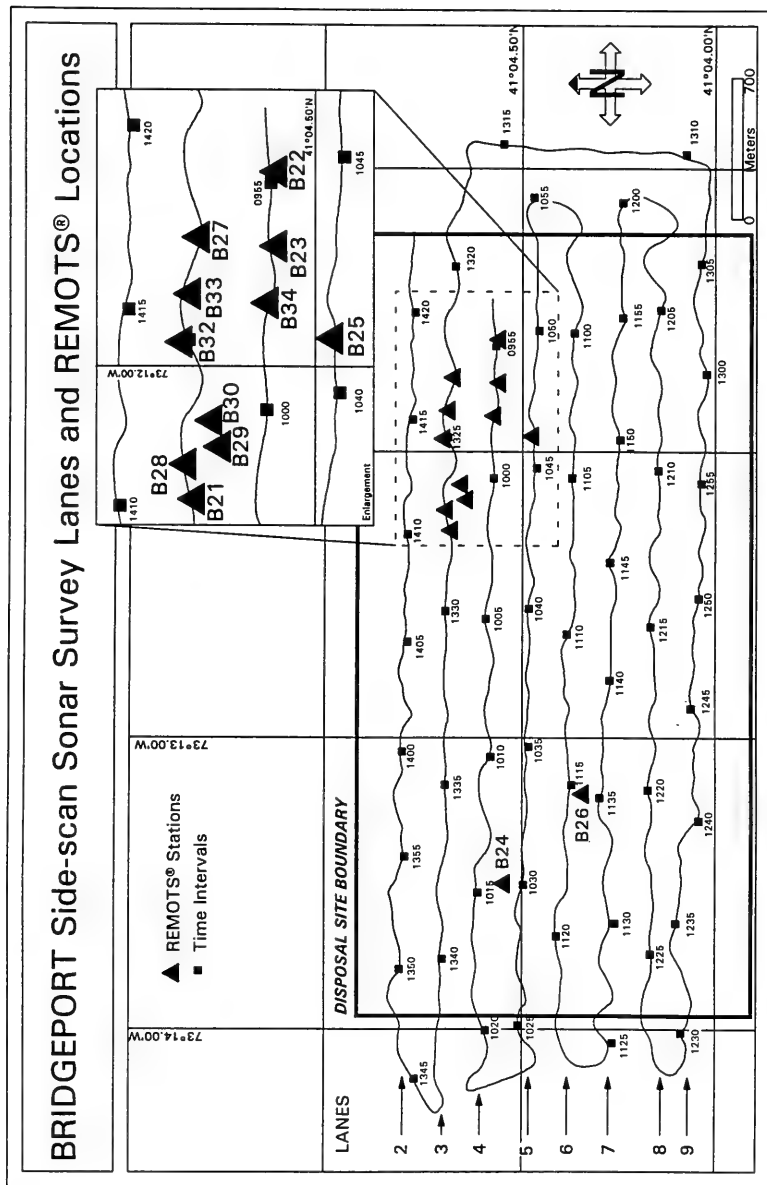
Figure 2-1. Vessel track of the side-scan sonar survey and locations of the selected REMOTS® stations

Thirteen REMOTS® stations were visited during the 4 August 1992 survey (Figure 2-1). Twelve of the thirteen stations were clustered in the northeast quadrant of the site where the presence of dredged material was suspected. Two other stations were situated in the western half of the site to characterize areas of suspected dredged material deposits there. Film from the REMOTS® camera was developed on the research vessel to verify that the photographs collected during the one-day sampling effort were usable. Three replicate

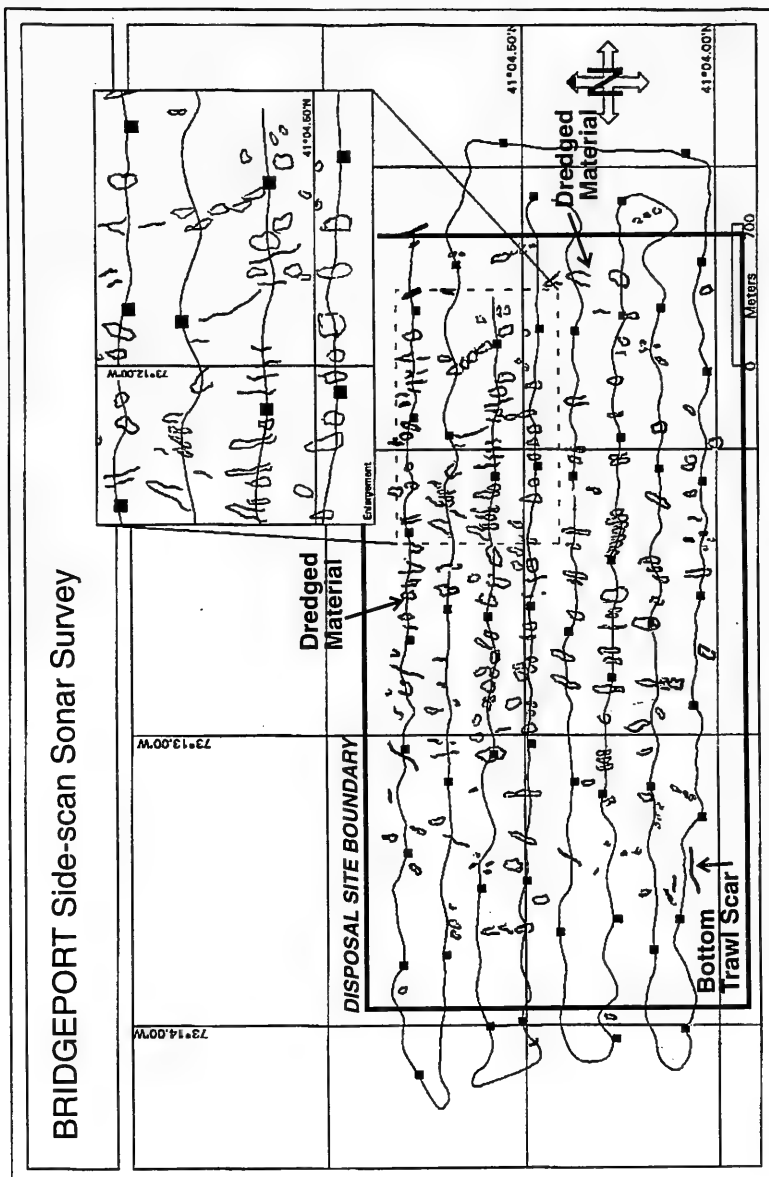
Figure 2-2. Bridgeport Disposal Site side-scan sonar survey mosaic. Annotations are outlines of visible features, as labelled on the example features.

The speed of the vessel was maintained at 3 knots while the sonar (i.e., towfish) was towed approximately 11 m from the seafloor. During the survey, the navigation system generated a plot of the ship's position with respect to the target survey lanes (Figure 2-1). Time was automatically annotated on the plot every 5 minutes. At the same time, the sonar record was annotated with time so that targets present on the sonar record could be transferred (compensating for cable layback) to the real-time navigation plots following the survey. The resulting mosaic of acoustic targets was used to establish the locations of the REMOTS® stations (Figure 2-2).

The habitat quality of infaunal benthos within the disposal site was, in general, stable. The average OSI for all stations was +7, and the presence of Stage III deposit-feeding assemblages indicated the benthic environment was relatively healthy. Among the 13 stations analyzed using REMOTS®, however, OSI values were not consistently high, nor were Stage III fauna present at every station. The OSI values at Stations B22, B23, B29, and B30 were less than +6 due to the presence of Stage I fauna only and the relatively low RPD depths (Figure 4-1). Two of these stations (B22 and B23) were stations where no dredged material was present (Figure 3-6), indicating no correlation between the presence of dredged material and OSI. In the remaining stations, the OSI values were high, ranging from +7 to +11, because Stage III organisms were present. High OSI values occurred even though the RPDs for these stations were relatively shallow. Although REMOTS® data indicated a healthy benthic community overall, recolonization was somewhat patchy in the area surveyed. The patchy distribution of Stage III assemblages may be caused by bottom trawling activities that disrupt the sequence of infaunal recolonization, or by long-term impact from contaminated dredged material. Both the scattered pattern of trawl marks and dredged material deposits are evident in the side-scan record at Bridgeport (Figure 2-2).

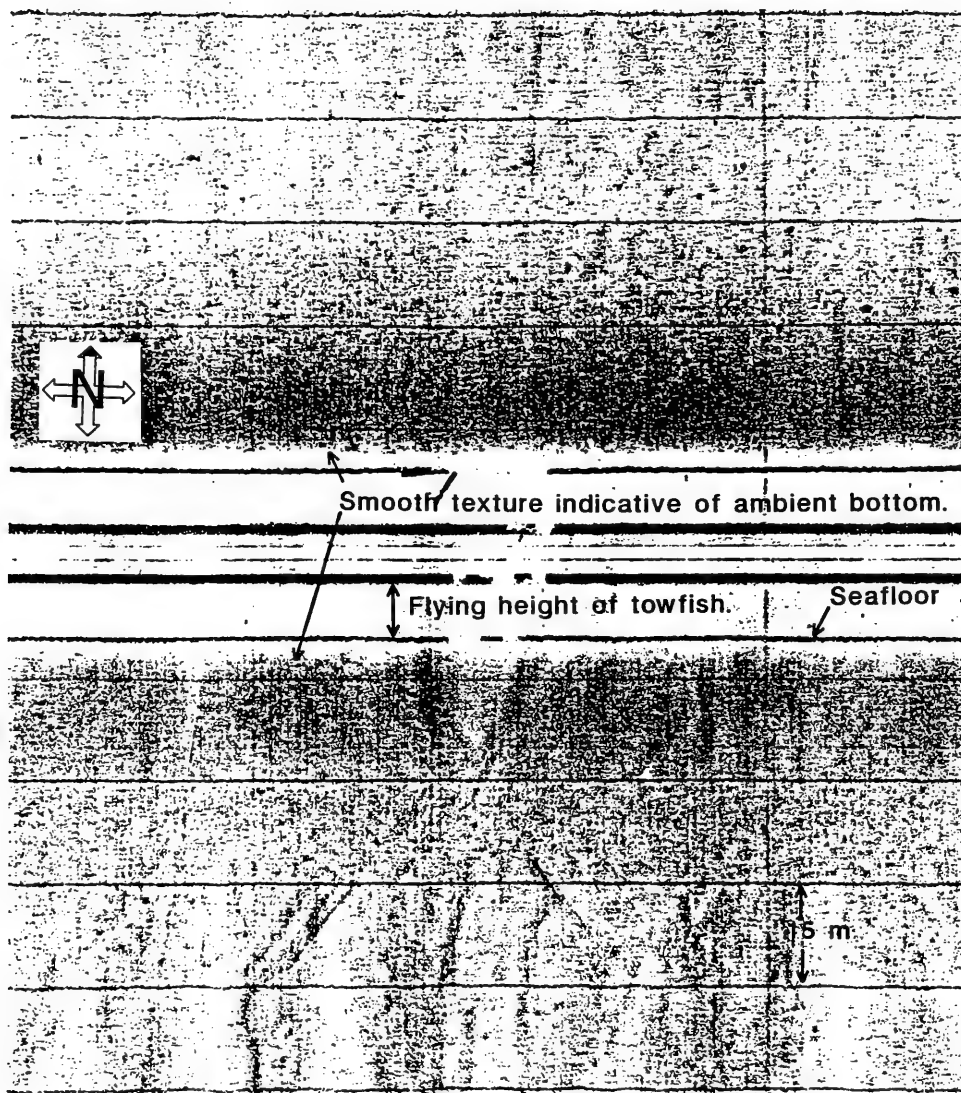
Figure 3-1. Example of a side-scan sonar record from the western portion of lane 2 showing the smooth, featureless image produced by the ambient silt bottom

The historical Bridgeport Disposal Site, based on the results of the side-scan survey, is mottled with relic, low-relief dredged material deposits. The natural or ambient bottom in the western portion of the site exhibits a predominantly smooth, low-reflectance, silty texture (Figure 3-1). Numerous low-relief, high-reflectance features, inferred to be dredged material, are present throughout the disposal area but are concentrated in the central portion of the site (Figure 3-2). The mottled, patchy appearance of these strong acoustic reflectors, or targets, is characteristic of dredged material deposits and is due to alternating patches of high- and low-reflectance materials. Strong reflectance of dredged material deposits relative to the ambient, smooth bottom is a function of increased acoustic backscattering at the surface of the deposit. This backscattering is likely related to increased microtopography and surface roughness (i.e., coarse-grained texture) of dredged material in comparison to smooth, ambient sediments. While storm activity may reduce the topographic relief of dredged material mounds, net deposition in Long Island Sound is slow, approximately 1 mm/yr. Coarse-grained dredged material covered by a thin surface deposit may be sonically detected with side-scan sonar which has a small degree of bottom penetration.

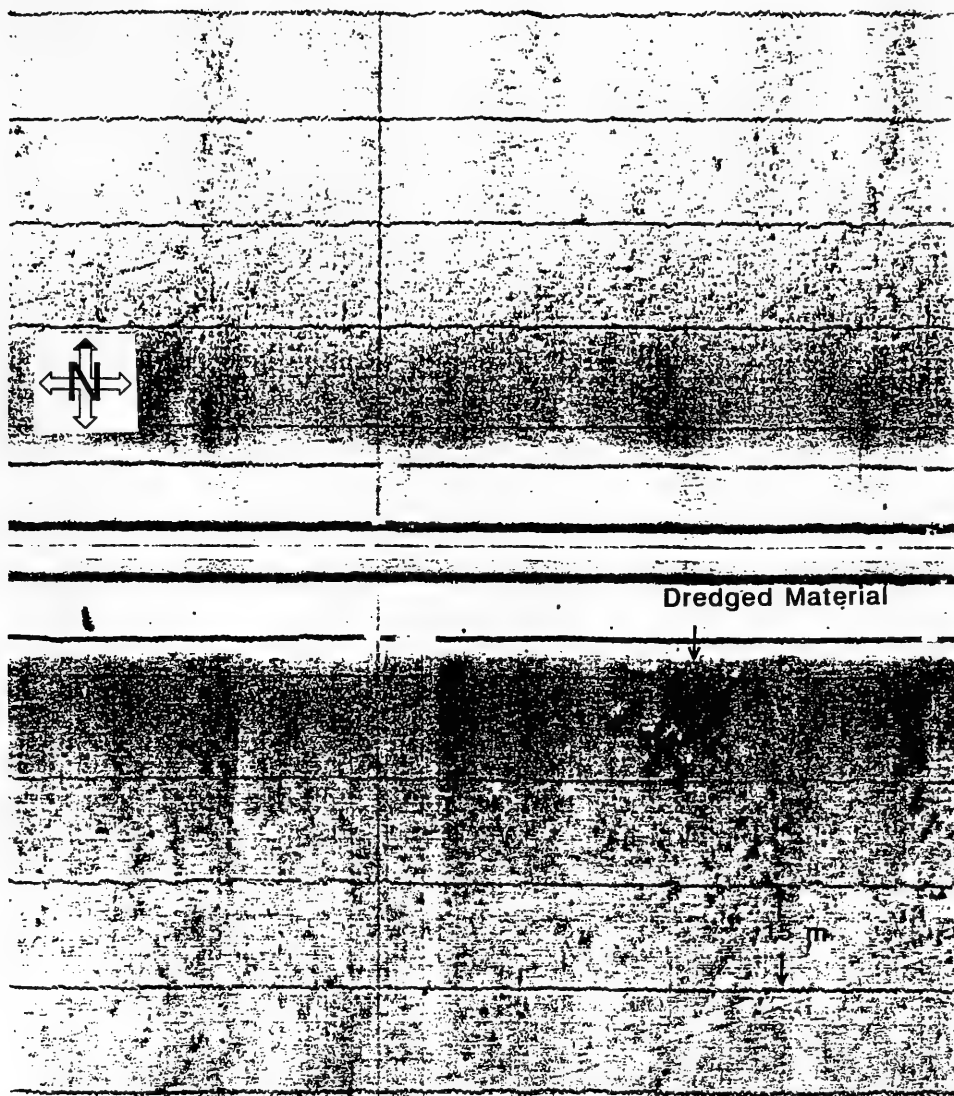
Figure 3-2. Example of a side-scan record from the eastern portion of lane 7 exhibiting mottled texture and low-relief patches of high-reflectance areas on low-reflectance ambient bottom

Recently deposited dredged material will typically form a localized, circular high-reflectance pattern in side-scan sonar traces (SAIC 1987, 1990c). The mottled appearance and low relief of dredged material in this survey suggest that the acoustic reflectivity of the material has decayed due to physical or biological reworking of the deposit or that natural deposition over the last fifteen years has covered portions of the relic dredged material.

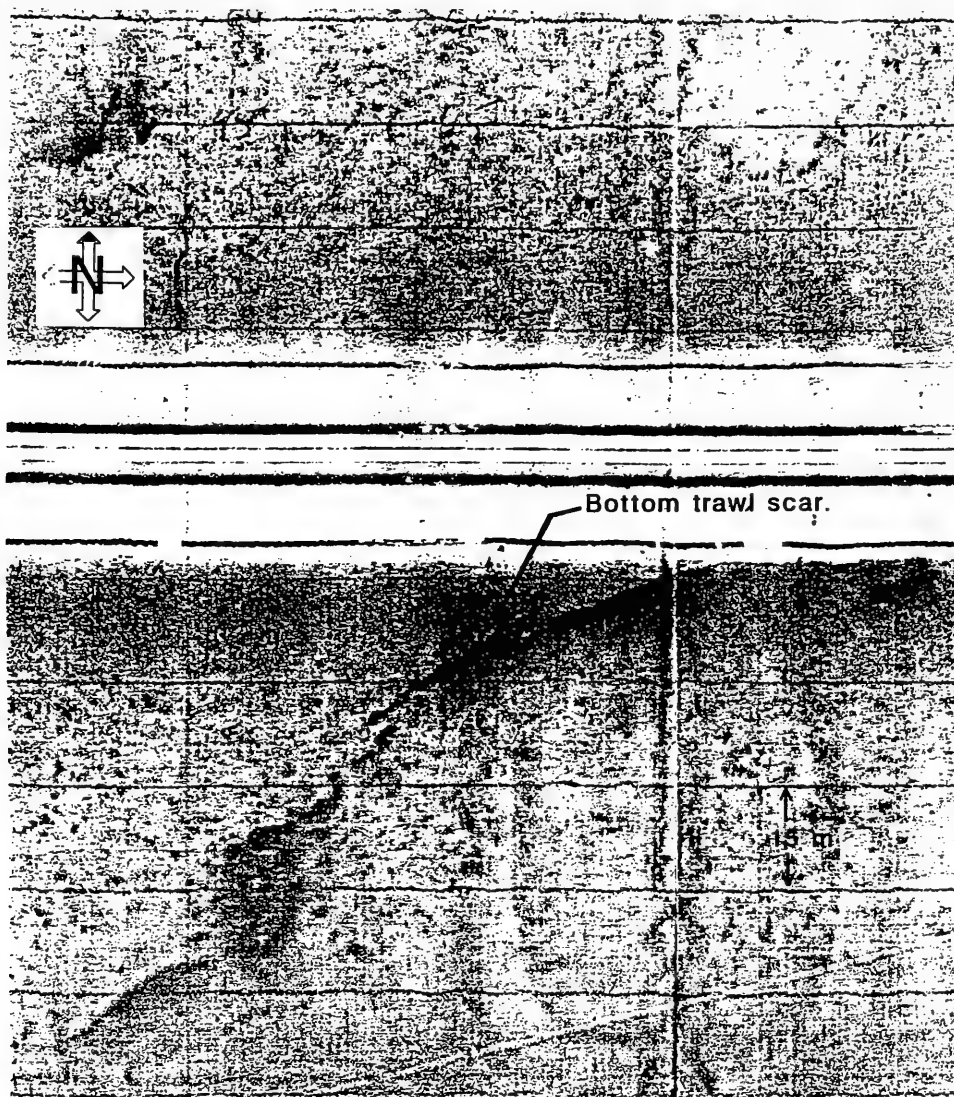
Figure 3-4. Example of a side-scan record (lane 9) showing evidence of bottom trawling

Some stations exhibiting relatively high modal grain sizes (1 or less) also contained shell fragments and mudclasts. Shell fragments were present in 25 percent of the Bridgeport photographs, and mudclasts were present in 50 percent of the REMOTS® photographs (Figure 3-3). Mud clasts are typically associated with the reduction of topographic relief due to physical and biological processes. While fine-grained sediment is reworked into ball structures and concentrated in topographic lows, coarse-grained materials, including shell fragments, are concentrated at the crest of the gradually decaying mound (SAIC 1984). Localized disturbances, such as trawling activities, may also disturb relic dredged material and initiate the formation of small mud clasts. Evidence of trawling was noted on the side-scan records (Figure 3-4).

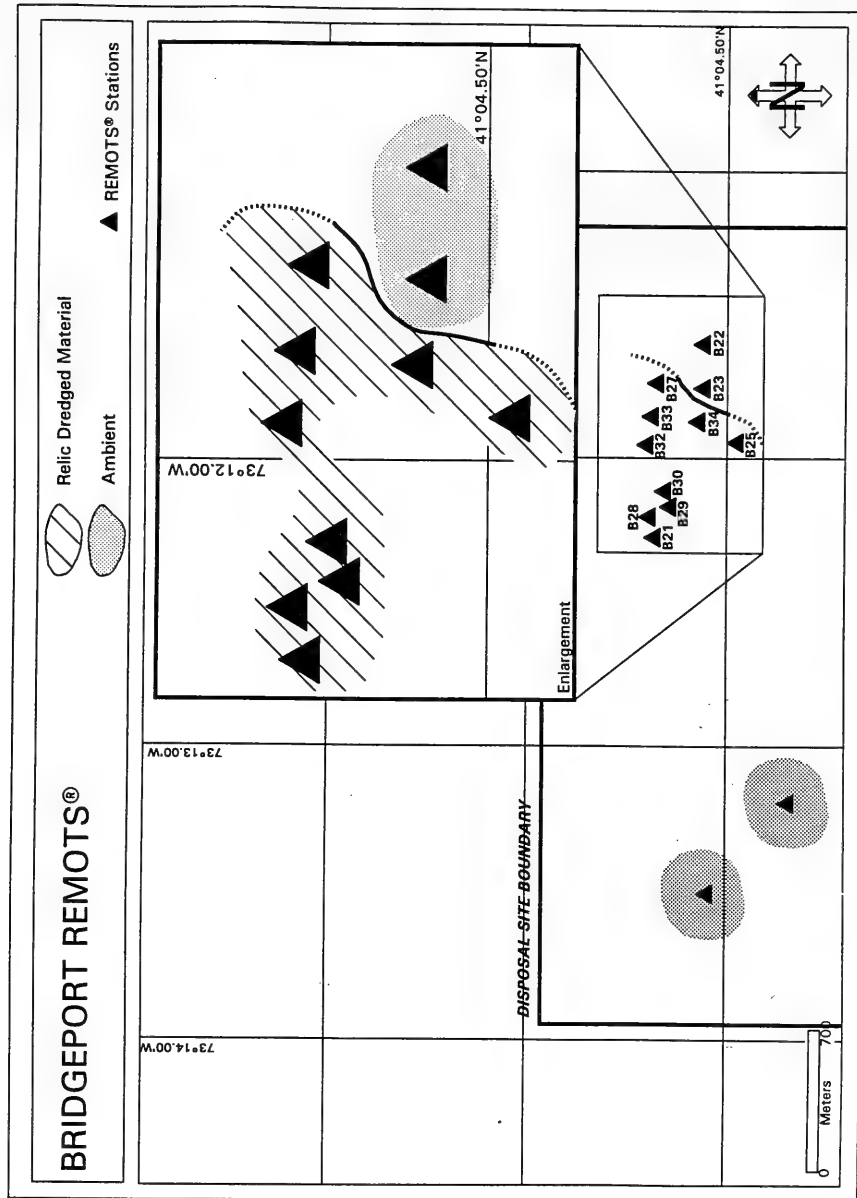
Figure 3-6. Relic dredged material distribution at the Bridgeport Disposal Site

Relic dredged material was detected in nine (B21, B28, B32, B33, B27, B29, B30, B34, and B25) of the 13 stations occupied (Figure 3-6). Dredged material was recognized by its coarse-grained, slightly reduced texture (Figure 3-7). Shell fragments were also observed. Relic dredged material did not contrast sharply with ambient sediments in terms of sediment color, reflectance, apparent RPD depth, or infaunal successional stage. Dredged material layers ranged in thickness from 12 to 18 cm and frequently exceeded the camera prism penetration depth. This indicates either that dredged material has remained in layers of this thickness in the area surveyed or that relatively thin dredged material layers have been buried with time by natural sedimentation. Two stations, B22 and B23, were characterized by ambient sediment (Figure 3-6). Both possible relic dredged material and ambient sediment were observed in some, but not all, of the replicate photos collected at the two westernmost stations, B26 and B24.

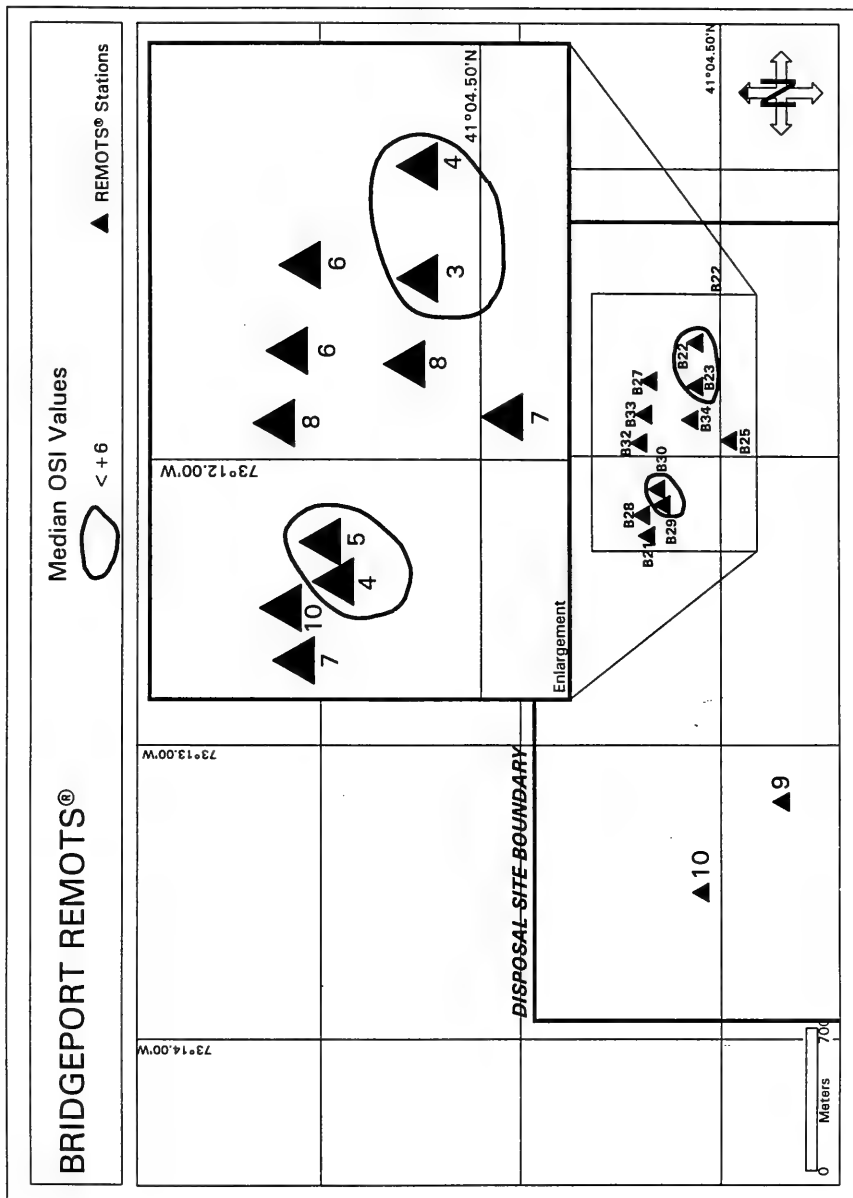
Figure 4-1. Median OSI values at Bridgeport Disposal Site REMOTS® stations

The Organism-Sediment Index (OSI) values reflect both the apparent RPD depths and the infaunal successional status of a REMOTS® photograph. OSI values can range from -10 (no apparent macrofaunal life and methane gas present) to 11 (deep apparent RPD, evidence of mature macrofaunal assemblages, and no apparent methane). Based on other studies, SAIC has determined that OSI values less than or equal to +6 are indicative of a "disturbed" benthic environment (i.e., erosion, dredged material disposal, hypoxia, etc.; Rhoads and Germano 1986). OSI values ranged from +2 to +11 for all replicates with a mean value of +7 for all stations. Among stations, there was no apparent pattern of OSI values. Those stations where dredged material was observed displayed mean OSI values ranging from +3.3 to +10. Mean OSI values for apparent ambient sediments ranged from +3.3 to +9.7. In comparison to mean OSI indices measured in the MQR mound in 1992 (+3.3 to +7), the range of mean OSI values observed in the Bridgeport Disposal Site fell within and slightly above those measured in the MQR mound. These data suggest disturbances within the Bridgeport Disposal Site were heterogeneous in their distribution.
